ECOLOGICAL AND HUMAN BENEFITS OF SEZ RESTORATION

Prepared by Michael Hogan for Homewood Mountain Resort

April 3rd, 2010

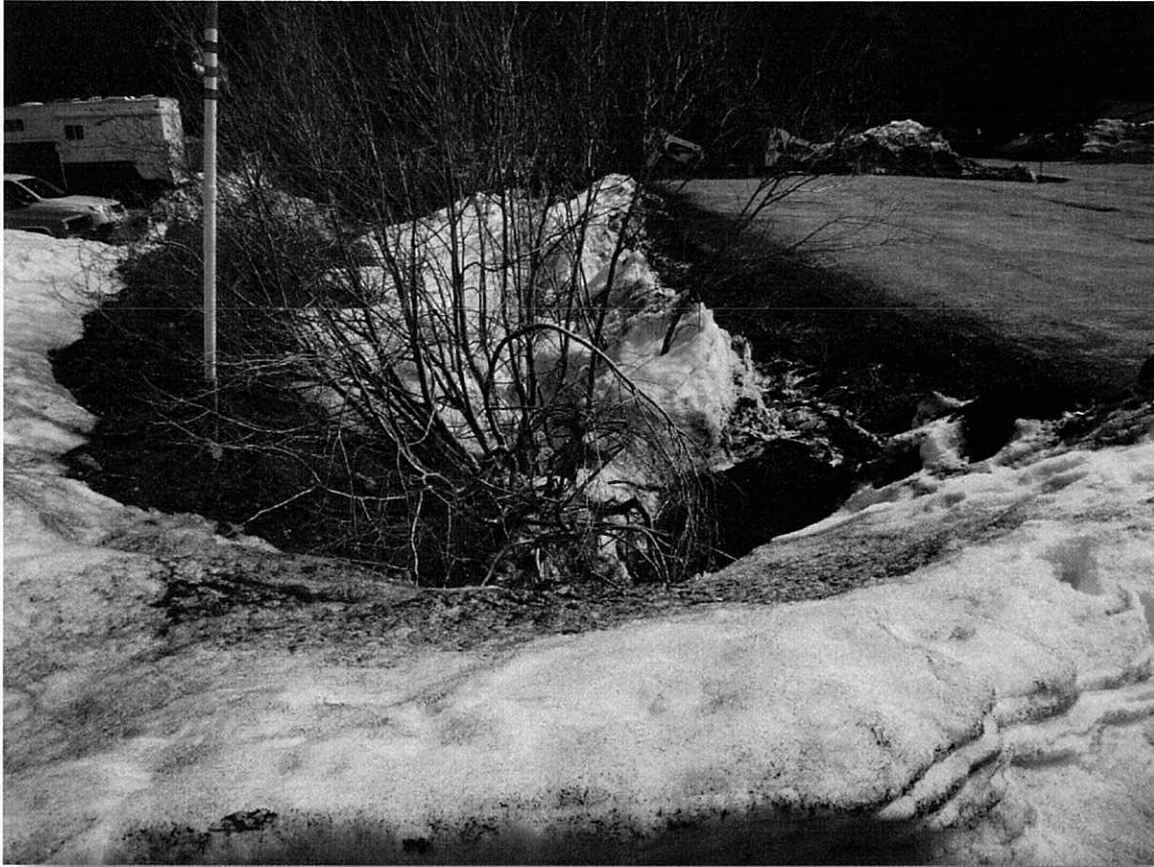
Figure 1: Photo of Homewood Creek showing constrained flow path and steep sided banks

The creek is currently constrained physically, ecologically and aesthetically.

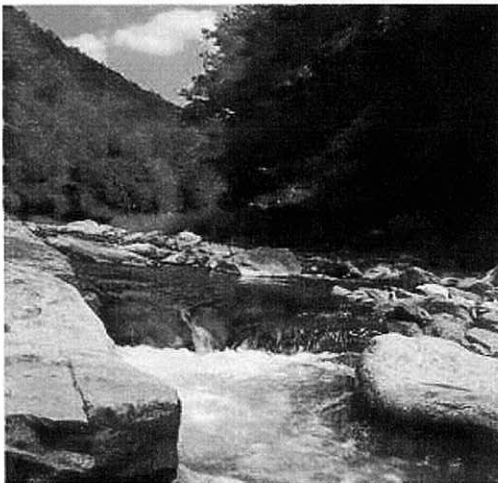
Figure 2: laminar to turbulent flow in a creek, showing oxygenation

- Bank erosion reduction
 - By widening the wetted cross sectional profile, flow rates are reduced, thus lowering the energy available for bank cutting and erosion.
- Fish passage
 - Fish passage potential will be enhanced by creating a more advantageous environment for small fish. The restoration plan includes small step pools and removal of the culvert which allows for more fish-friendly habitat.
- Aeration
 - Aeration is the process of introducing oxygen into the water column. Natural streams, especially in high gradient environments such as exist in the Homewood Creek watershed, tend to be well aerated due to the multiple steps that occur in the stream channel. When water is forced over rocks or other obstacles, oxygen is introduced as water goes from laminar to turbulent flow, as shown in figure 2.

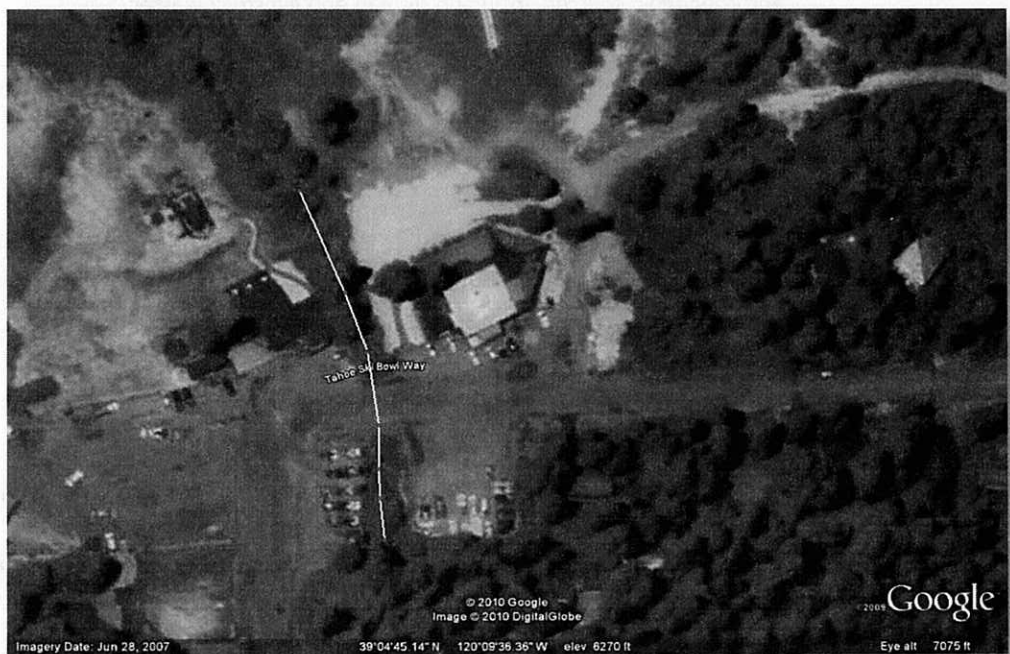
Figure 4: Google Earth image showing location of stream restoration. Approximate length of restoration: 340 feet

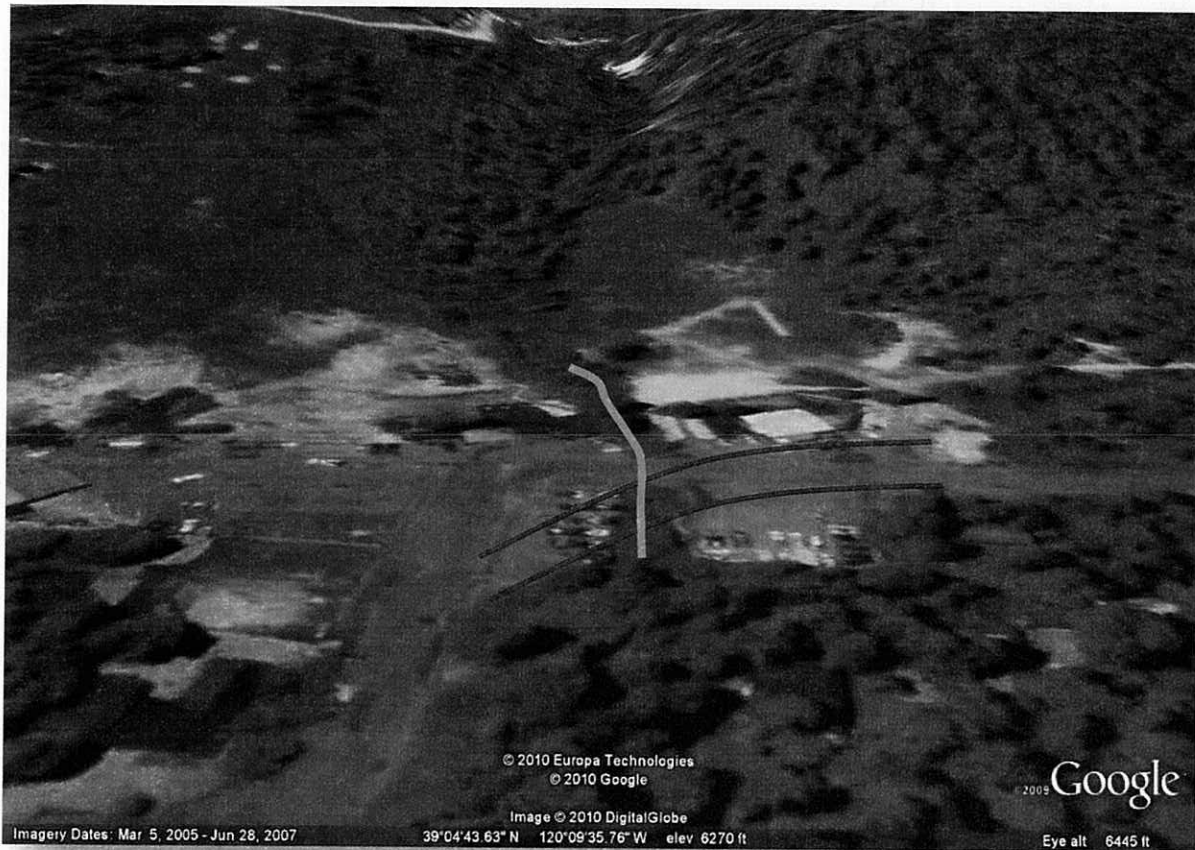
Figure 5: Oblique Google Earth image showing approximate alignment of stream restoration and approximate new road alignment

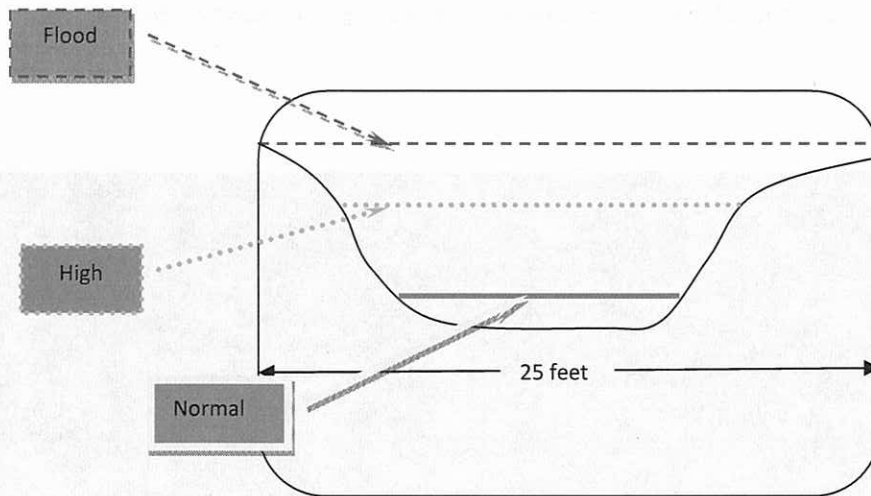
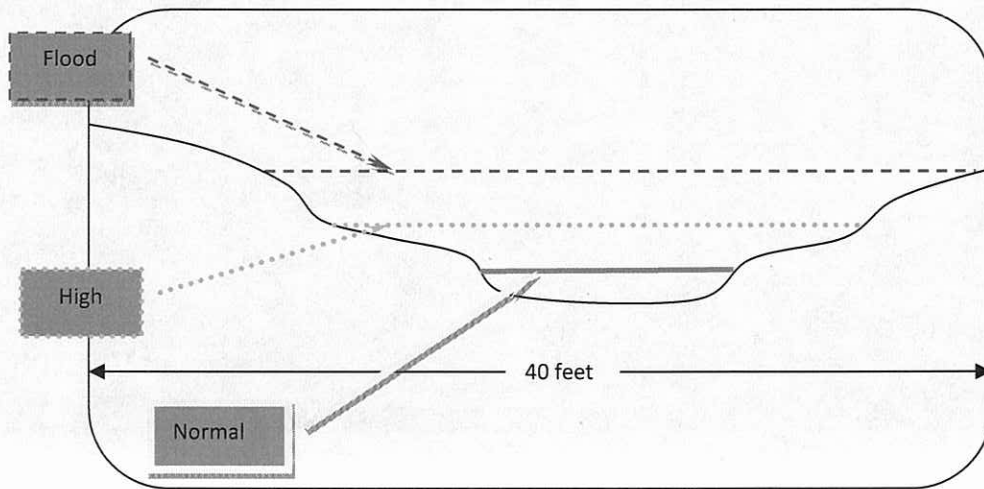
Figures 6 and 7 showing typical cross sections of before (fig 6) and after (fig 7) restoration. Prior to restoration, a give volume of water is constrained. That same volume, after restoration has more area to fill, thus reducing flows and energy at a given point. This figure compares conceptual normal, spring high and flood or extreme flows, indicating that extreme flows are more likely to exceed bank full height prior to restoration.

- Flood attenuation
 - By widening the stream cross section, we allow more space for water to be contained in. This basic principle of stream restoration is shown in Figures 6 and 7, which describe graphically how widening the stream channel and incorporating multiple flood plains allows water to stay within the banks. Figure 6 shows how flood flows are likely to exceed bank full capacity and flood the surrounding areas, thus creating ecological and human liabilities.
